KENTISH RIVER STOUR ESTUARY

Update 20th August 2010 for Sandwich Sailing and Motor Boat Club
Based on physical surveys: 13-05-2010, 16-07-2010, 08-08-2010 & 11-08-2010.
Surveys and compilation by Robert Holden. Tel: 07973 468961.

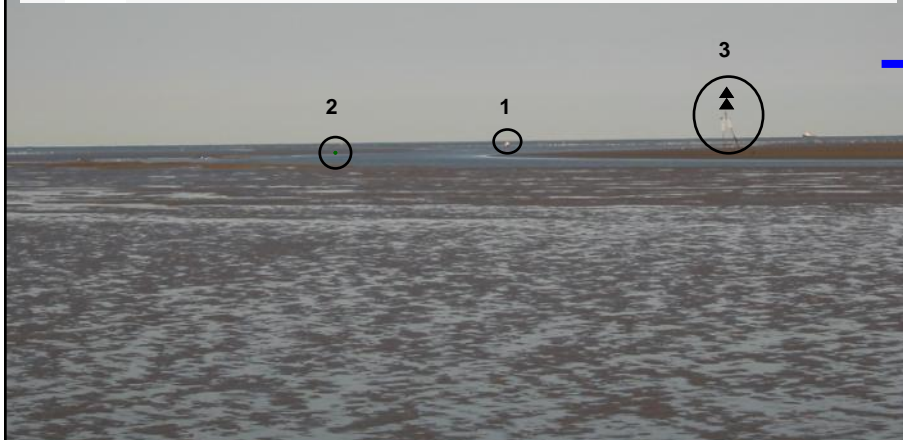
1. Red and White Sandwich Fairway Buoy marking the entry to the river.
 2. Small Green starboard hand buoy. Channel marker No. 1.
 3. North Cardinal Tower. Channel Marker No. 2.
- Notes. Channel Marker number 2 (North Cardinal) is now - 14th August 2010 - some way to the south of the channel as this bend in the channel continues to move north. This photo taken May 2010. View looking out to sea.

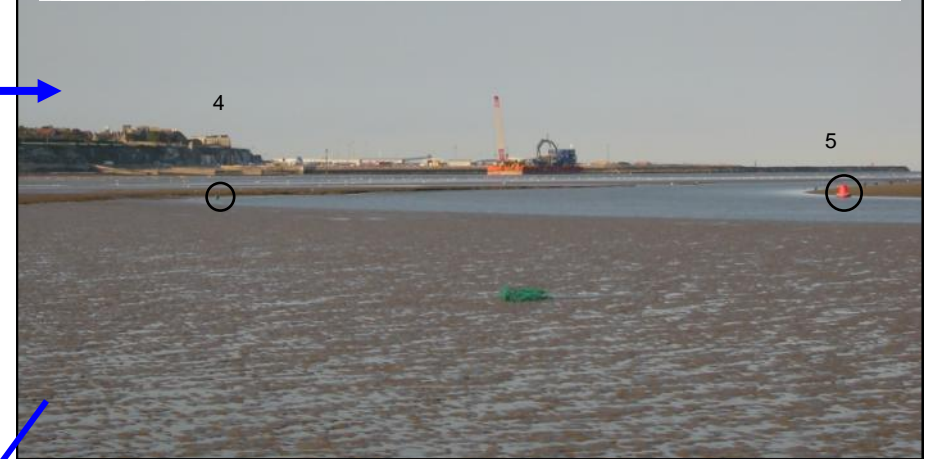
4. No. 3 Buoy on the apex of the first notable bend.
 5. No. 4 Buoy a little way around the bend inward resting on the waters edge at low tide.
- In the foreground is a clump of green fishing net shamefully discarded. One of many pieces seen. View looking down river and out to sea.

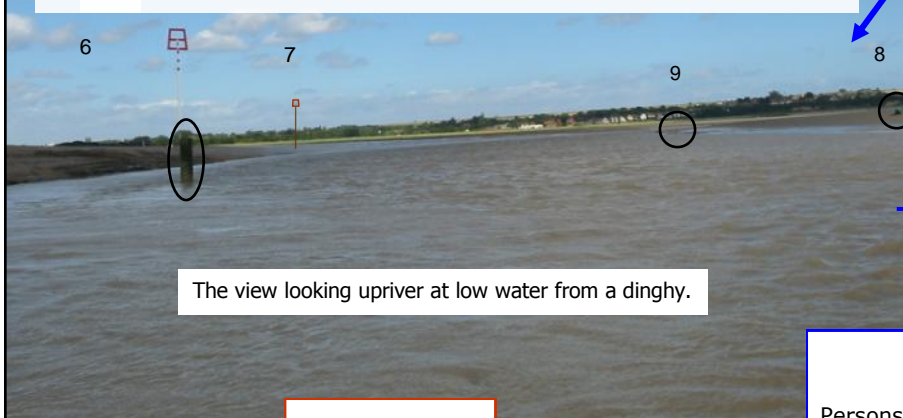
6. No. 8 - Port Hand Beacon. Note that it is attached to an old wooden pile revealed during recent river realignments. This particular beacon is awash at a tidal height of 7 meters (High Springs) at Dover.
7. No. 10 - Beacon at present properly on the very edge of the fairway.
8. No. 7 marker (Buoy) - a little way out of the fairway as the channel moves away from it.
9. No. 9 marker (Buoy) on the mud but close to the fairway.

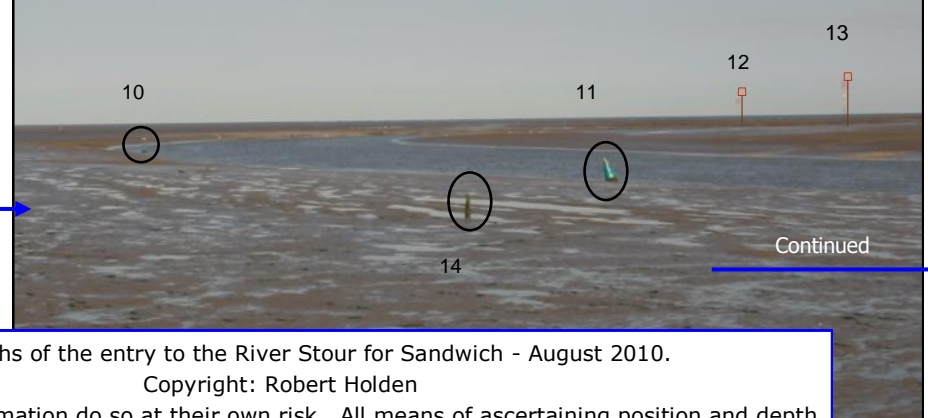
The view looking upriver at low water from a dinghy.

10. No. 11 - Buoy.
11. No. 13 - Buoy.
12. No. 12 - Beacon. This marks an old river bank alignment and is now considerably out of position.
13. No. 14 - Beacon. Comments the same as for No. 12 Beacon.
14. Old fishing stake sticking up above the mud. There are many of these scattered indiscriminately in Pegwell and Sandwich Bays.

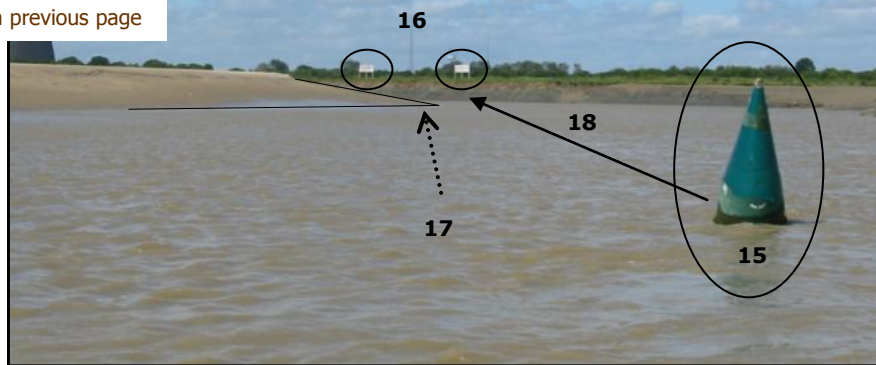
- 15. No. 13 - Buoy.
- 16. Two white speed and restrictions notice boards.
- 17. Shellness (south) side edge of the river at low tide.
- 18. Arrow showing how a straight line course from this buoy to the right hand notice board will give just enough safe clearance around Shellness.

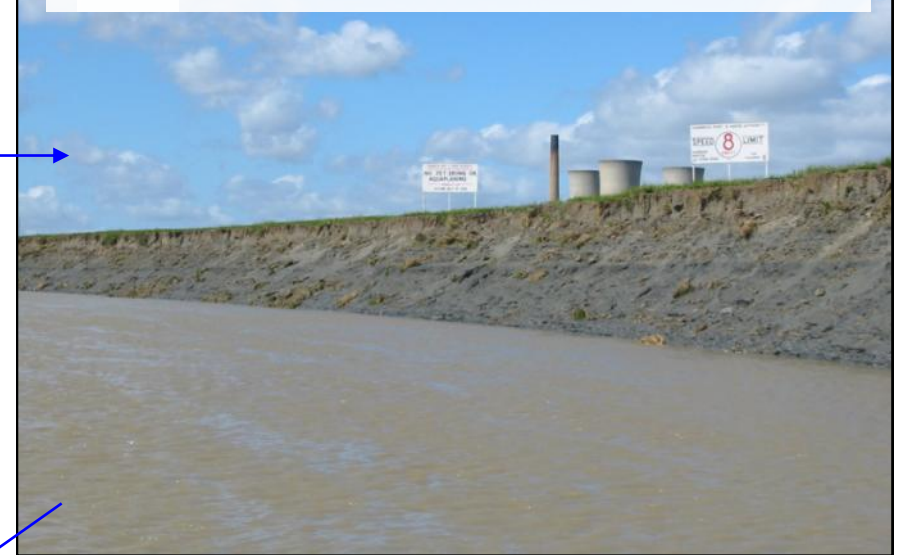
This picture shows how much the river is eating away at the bank beneath the notice boards and how deep the water is at high tide so close to these boards.

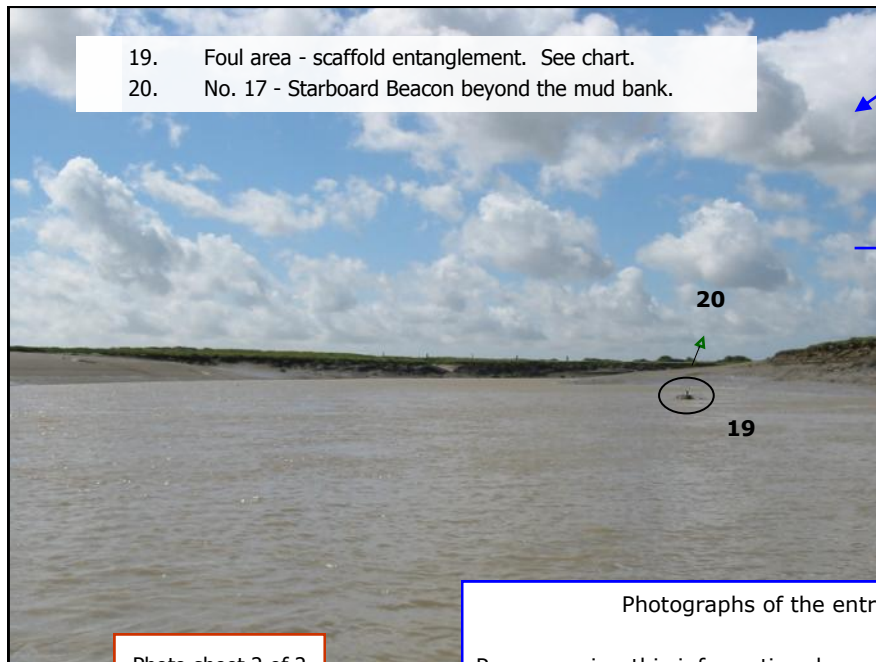
- 19. Foul area - scaffold entanglement. See chart.
- 20. No. 17 - Starboard Beacon beyond the mud bank.

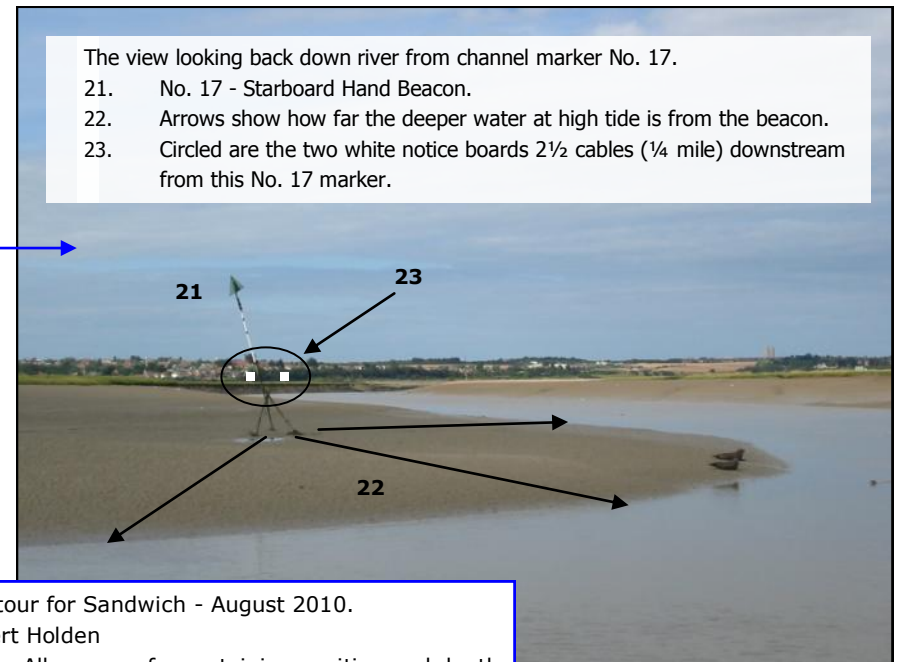
The view looking back down river from channel marker No. 17.

- 21. No. 17 - Starboard Hand Beacon.
- 22. Arrows show how far the deeper water at high tide is from the beacon.
- 23. Circled are the two white notice boards 2½ cables (¼ mile) downstream from this No. 17 marker.
